Research Article

CABLE STRESS IS AN INFLUENCING FACTOR IN AN INDUCTION MOTOR VIBRATION-A CASE STUDY

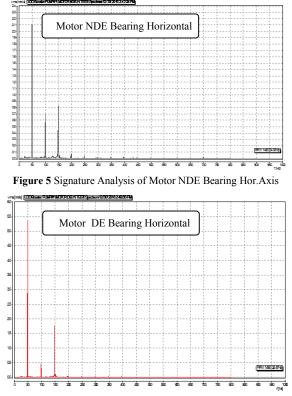
Vibration signature analysis of motor's non-drive end & drive end horizontal axis vibration were done (Figure:5 & 6)

Above study of the signature analysis (Figure:5) & (Figure:6) indicates that amplitude is dominant in 1* shaft running speed

and the next dominant peaks are the 2^{nd} .& 3^{rd} .*shaft running speed. S P Nogal & D L Lalwani [7] in an elaborate experiment had observed in an unbalance situation overall

RMS value in horizontal direction is high compared to vertical direction and first order amplitude is predominant. In a similar experiment V.Hariharan & PSS Srinivasan [6] had experimentally proved that in a spectrum dominant peak at 2* shaft running speed indicates shaft misalignment. Based on the above two studies the two spectrums clearly indicated that there is still remains residual unbalance in the motor and it is compounded with misalignment between the motor and the blower unit.

Till this stage the cause of abnormal vibrations were detected by using the diagnostic tool vibration signature analysis but though the overall high vibrations had reduced it had not totally come to satisfactory level as per the ISO Standard [1]. The 2nd vibration spectrum analysis still now shows unbalance of the motor and also misalignment

It is evident from the above phase angle analysis that there is unbalance and also misalignment as seen from the vibration signature analysis (Fig:5) & (Fig:6). As the motor's rotor had already been balanced and the vibration severity in the solo run of the motor without the coupling was well within the accepted norms [1] so the possible cause of further unbalance in the motor could be generated from the coupling which was fitted on the motor shaft after the balancing and the same was to be investigated. As misalignment was also contributing factor to the overall vibration in the coupled condition it will also be checked and corrected but after the balancing of the rotor with the coupling has been done.
